Todd Prager & Associates_{LLC}

MEMORANDUM

RE: Tree Assessment for 39247 Hood St, Sandy, OR 97055

Attachment 1

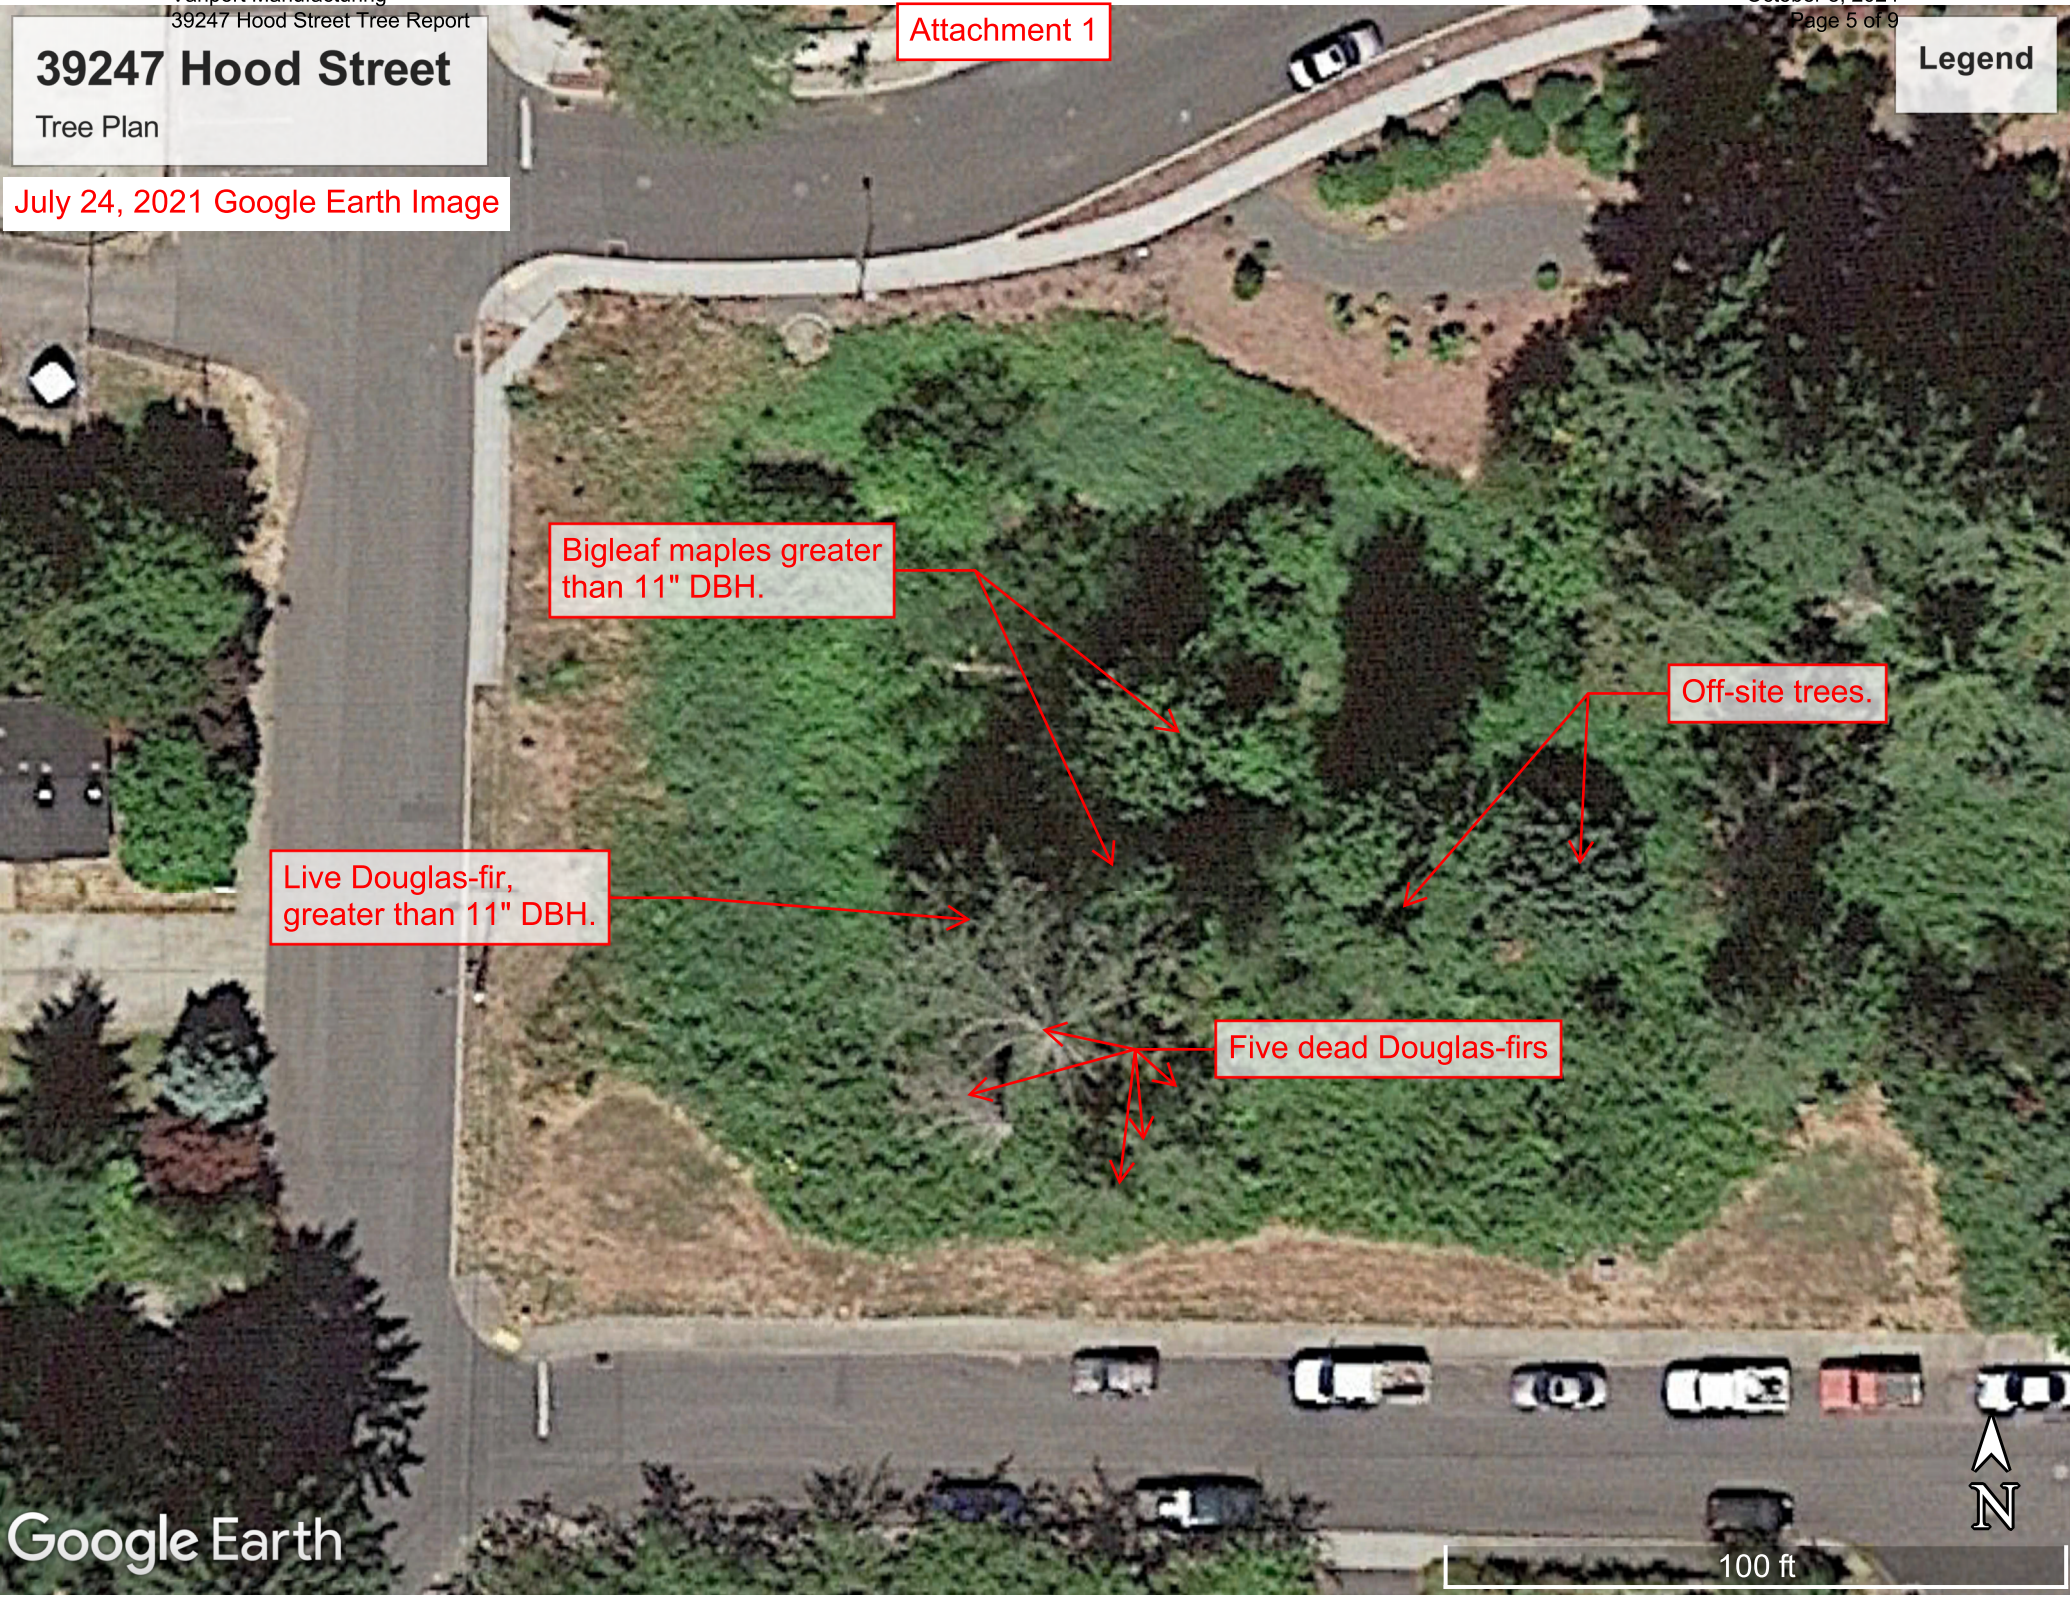
Bigleaf maples greater than 11" DBH.

Live Douglas-fir, greater than 11" DBH.

Five dead Douglas-firs

Off-site trees.

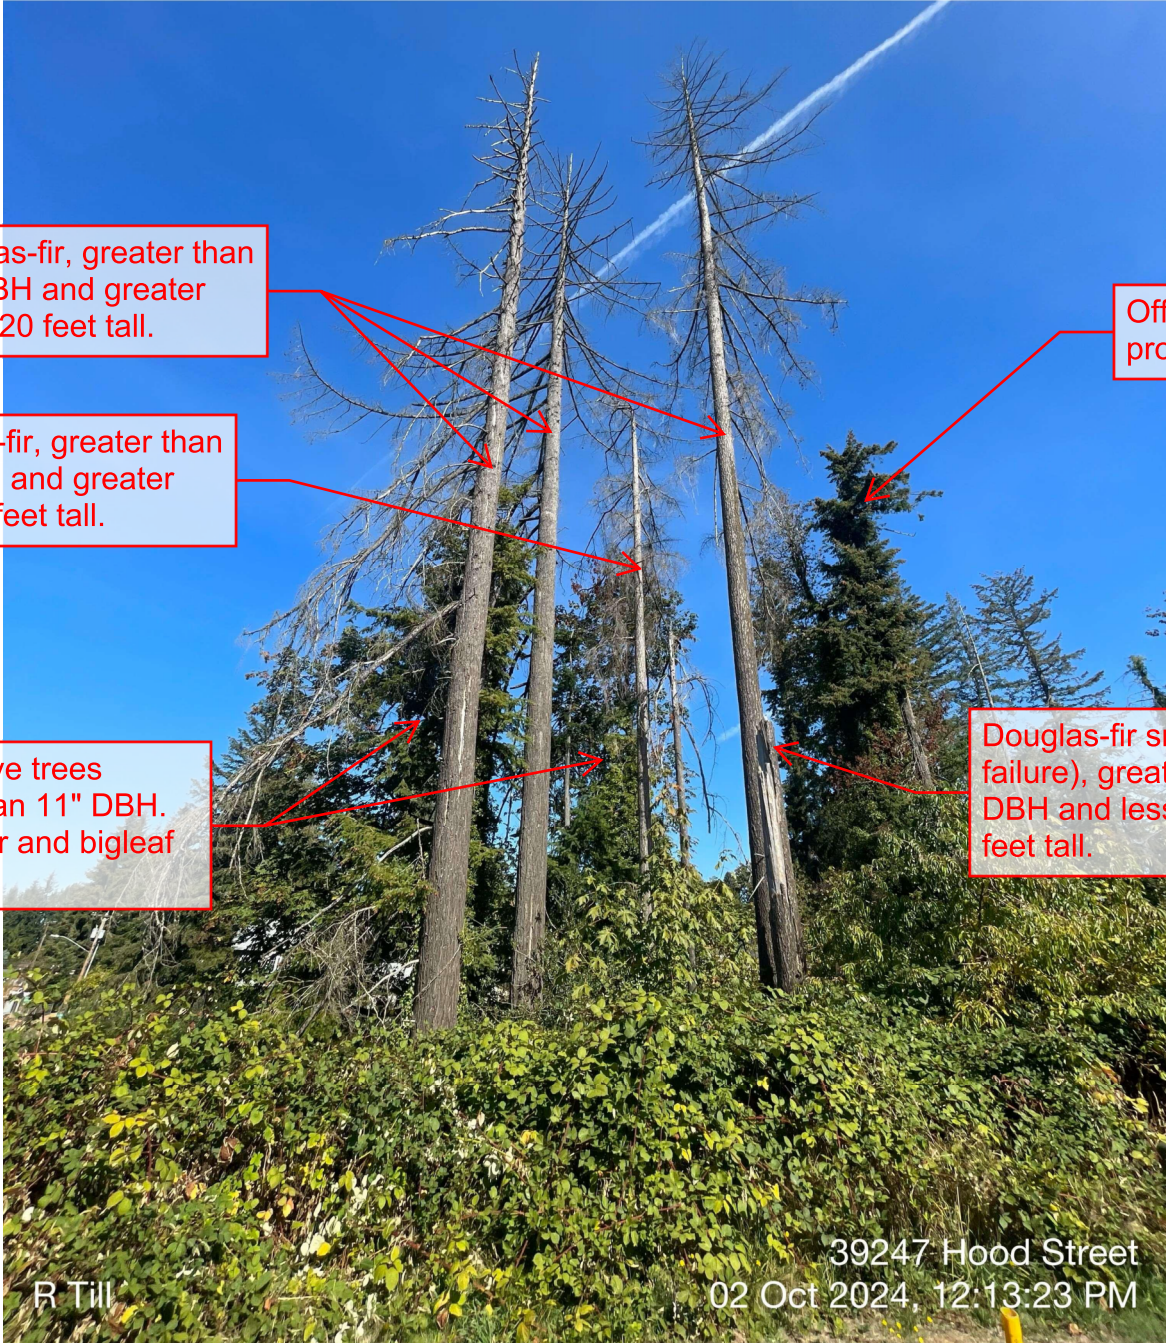
South Elevation

Douglas-fir, greater than 20" DBH and greater than 120 feet tall.

Douglas-fir, greater than 12" DBH and greater than 50 feet tall.

On-site, live trees greater than 11" DBH. Douglas-fir and bigleaf maples.

Off-site trees on property to east.

Douglas-fir snag (prior failure), greater than 12" DBH and less than 20 feet tall.

Four of the dead trees present a hazard or danger to person or property and the hazard or danger cannot be reasonably alleviated by treatment or pruning. The fifth dead Douglas-fir does not pose a hazard or danger to persons or property due to the prior stem failure. The dead trees should be removed or reduced (topped) at a height no greater than 20 feet. Reducing the trees to less than 20 feet would retain habitat while eliminating the risk of a tree failure reaching parked cars or people using the sidewalk.

Removal should be performed by a qualified arborist.² Tree removal should be performed in a controlled manner (directional felling or rigging) to avoid impacts to adjacent live trees to be retained.
