# **General Land Use Application**

City of Sandy

Subject: Blue spruce sp. 32

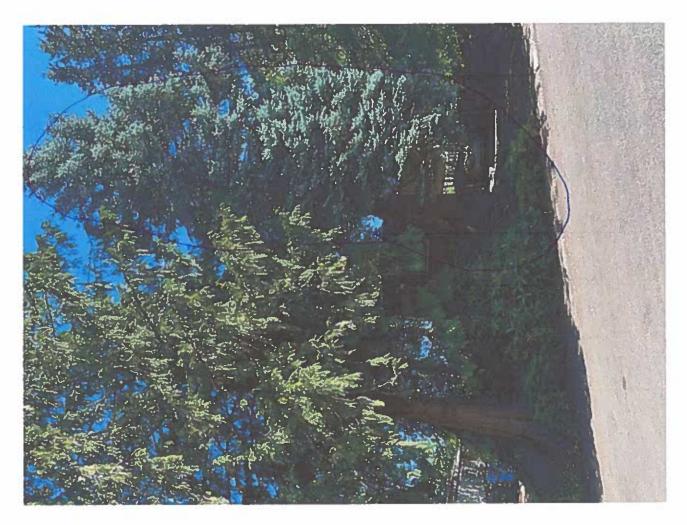
#	Product or service	Description	SKU	Qty	Rate	Amount
1.	Tree removal	Remove hazardous Blue spruce tree with very heavy lean. This tree will only continue to get more hazardous due to its placement and its phototropic inclination. Cut large trunk wood into about 15-16" firewood lengths and leav along side of driveway/road for pickup. Chip and haul all limbs/debris with full clean up, rake and blow off work area.	4.0	1	\$700.00	\$700.00
			Total			\$700.00
