## MEMORANDUM

**RE:** Tree 13.1, 15, and 194 Removal at Tickle Creek Development

**TREE DEMO PLAN**  
**TICKLE CREEK APARTMENTS**  
**DUBARKO DRIVE, SANDY, OREGON**

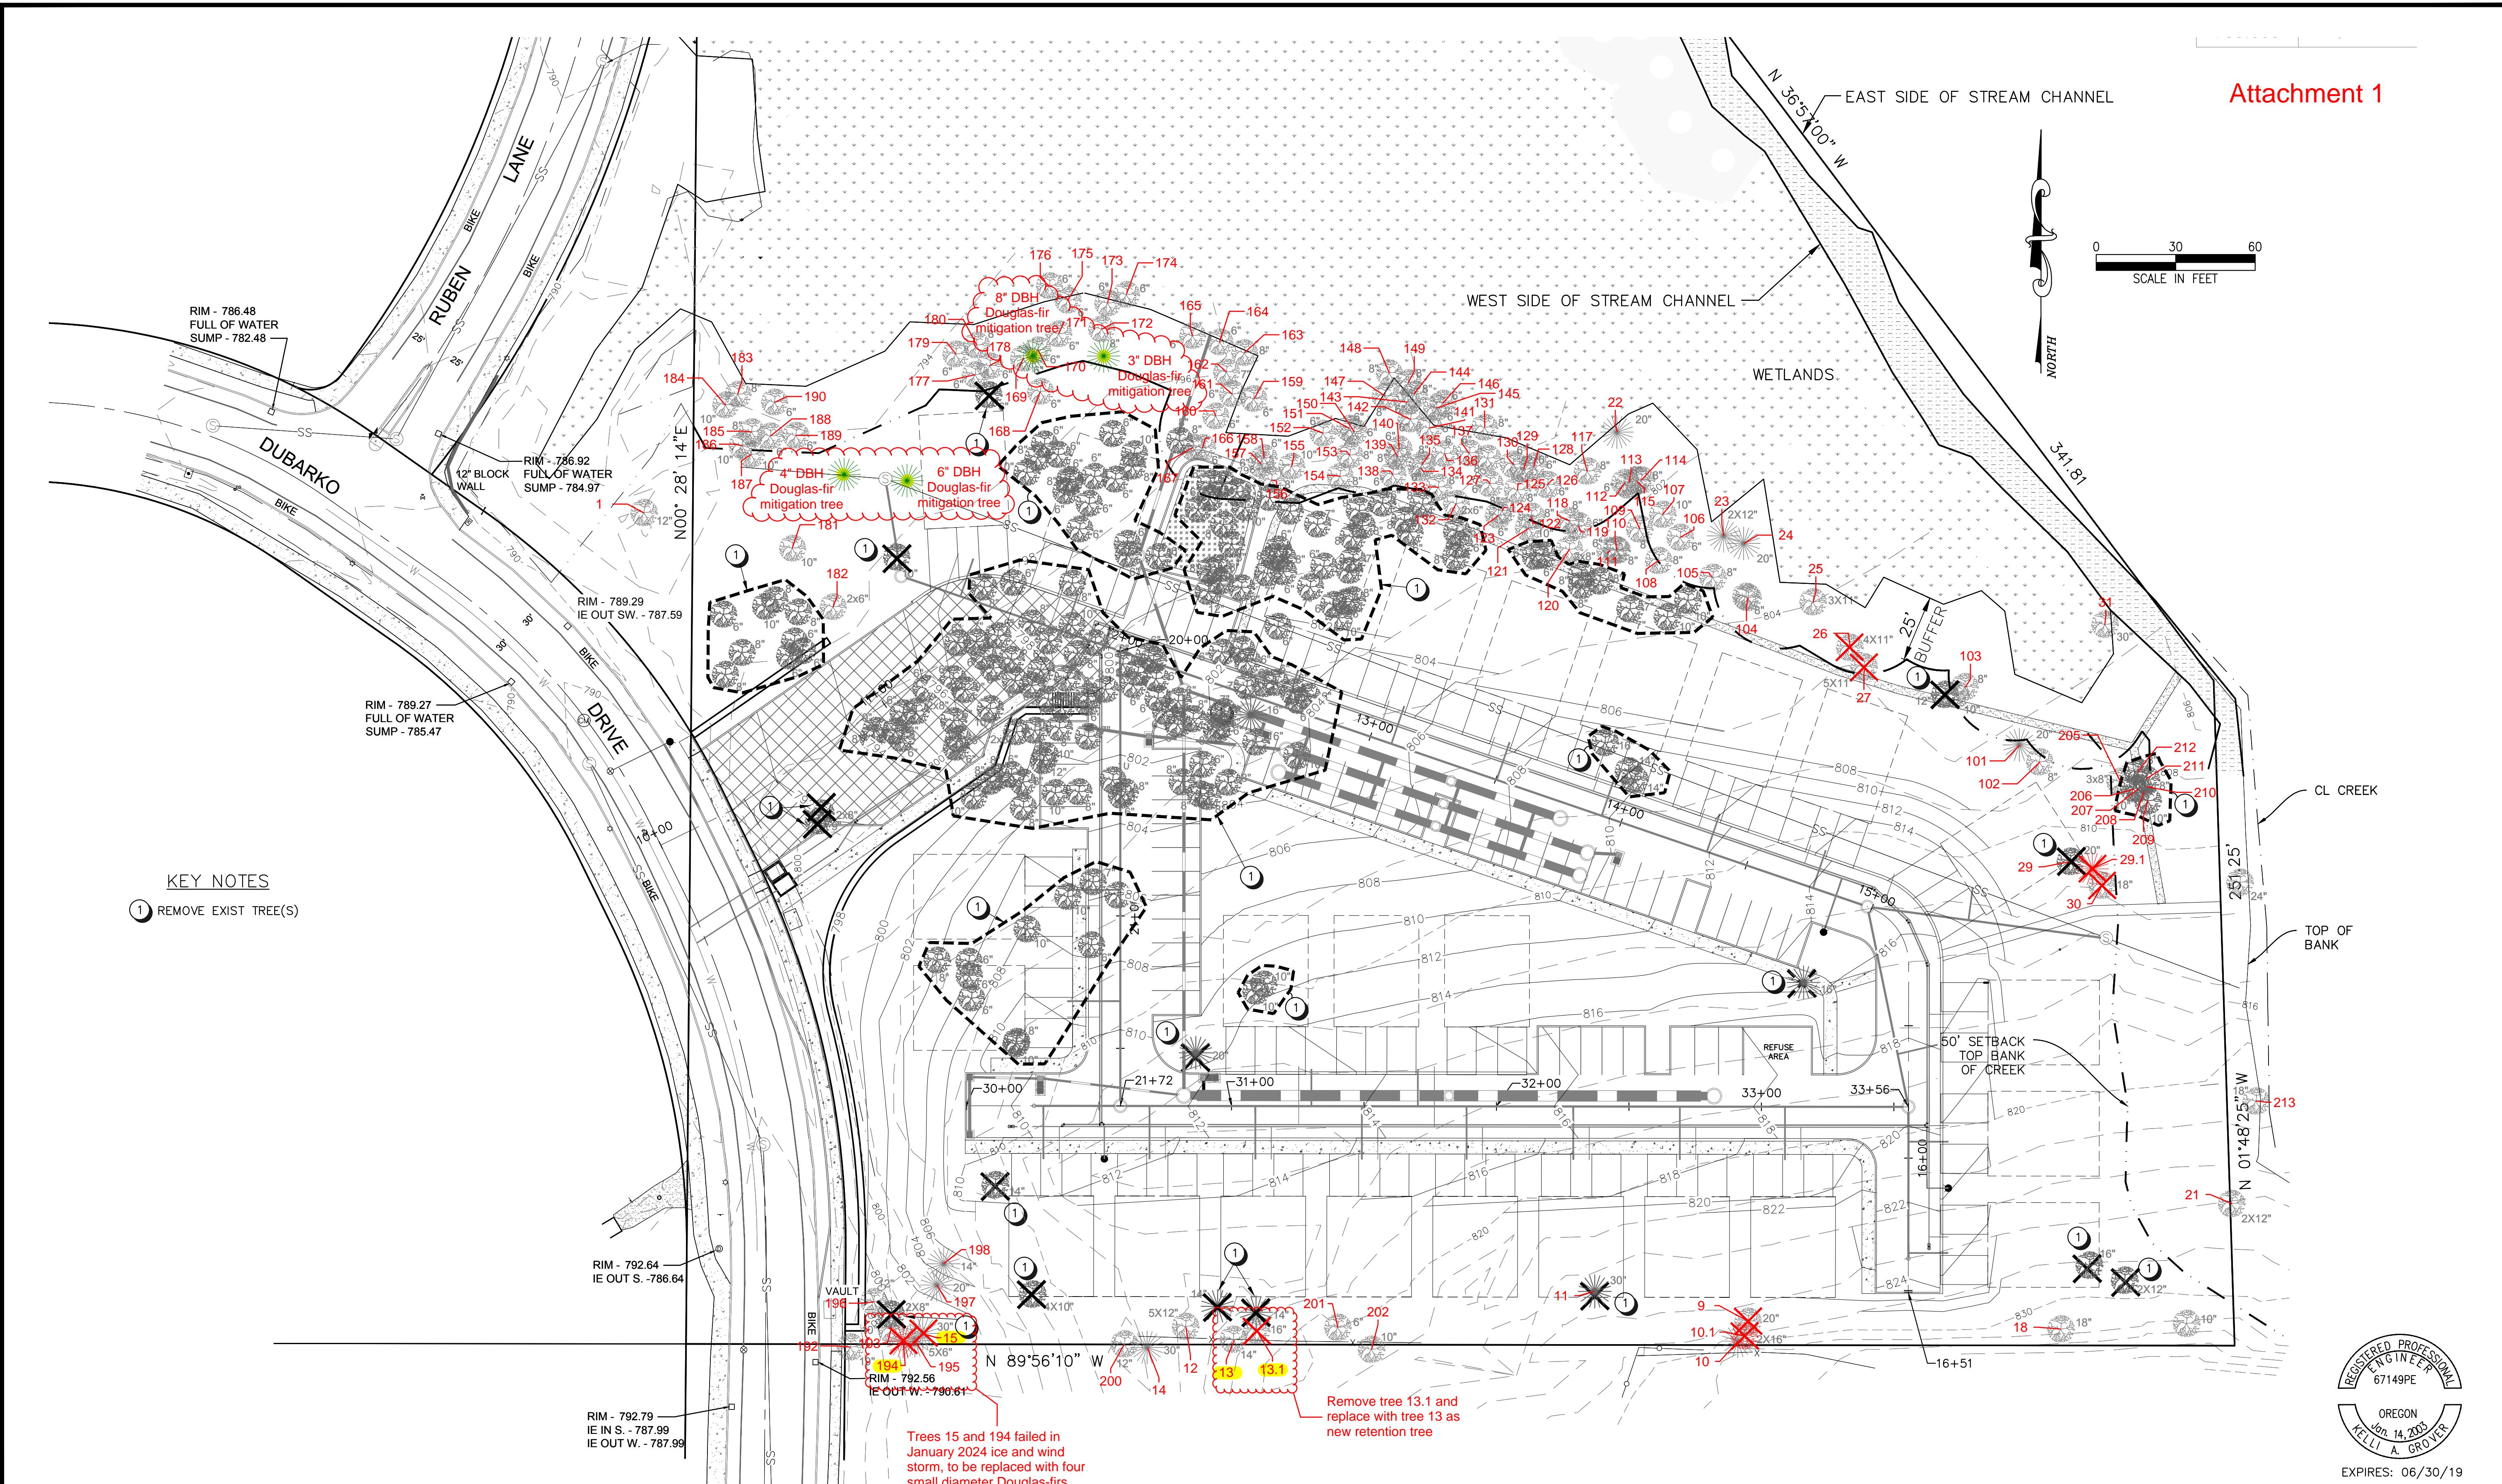
This memorandum is to document the removals of tree 13.1, a 14-inch DBH red alder (*Alnus rubra*), tree 15, a 28-inch DBH Douglas-fir (*Pseudotsuga menziesii*), and tree 194, a 12-inch DBH western redcedar (*Thuja plicata*) at the Tickle Creek Development in Sandy, Oregon. Attachment 1 is a site map with the highlighted tree locations. Attachment 2 is the complete tree inventory for the site.

Tree 13.1 was previously incorrectly surveyed and was recently found to be only four feet from the lot 20 house foundation. This tree is recommended for removal due to root conflicts with foundation excavation. It will be replaced with adjacent tree 13, a 14-inch DBH sweet cherry (*Prunus avium*) which is in good health condition and will serve as a new retention tree.

Trees 15 and 194 failed during the January 2024 ice and windstorm. These trees will be replaced by four small diameter Douglas-firs to the north as shown on the site map in Attachment 1. All four trees are in good health condition. Photos of the replacement Douglas-fir trees are provided in Attachment 4.

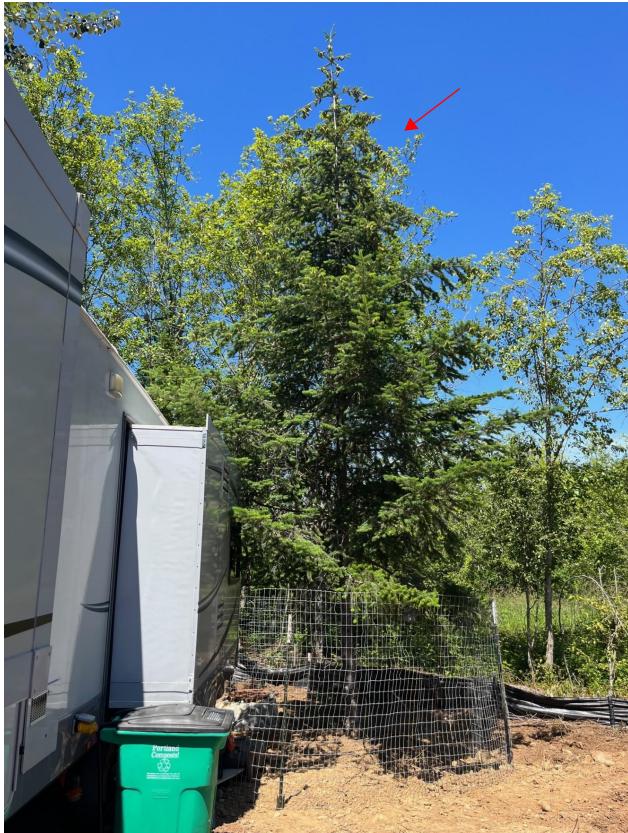
6-inch DBH Douglas-fir

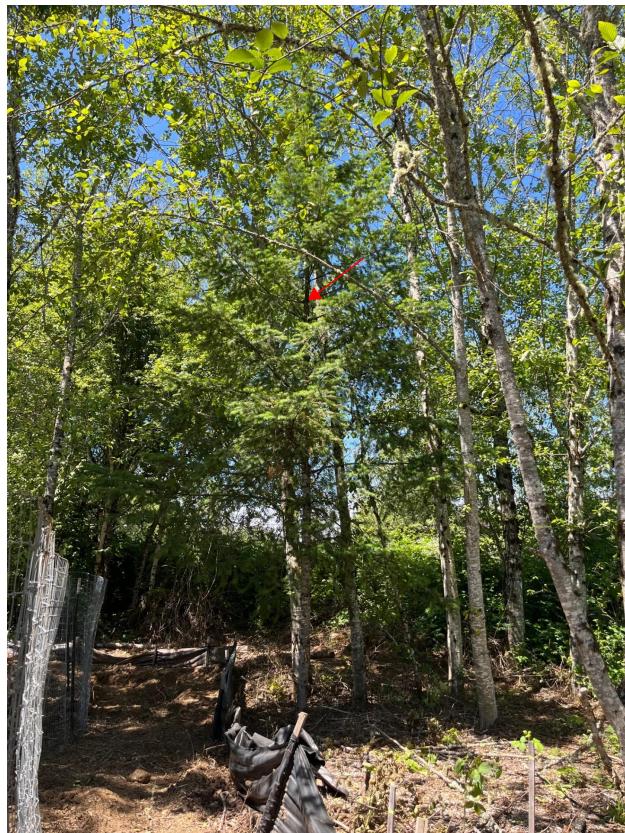
4-inch DBH Douglas-fir

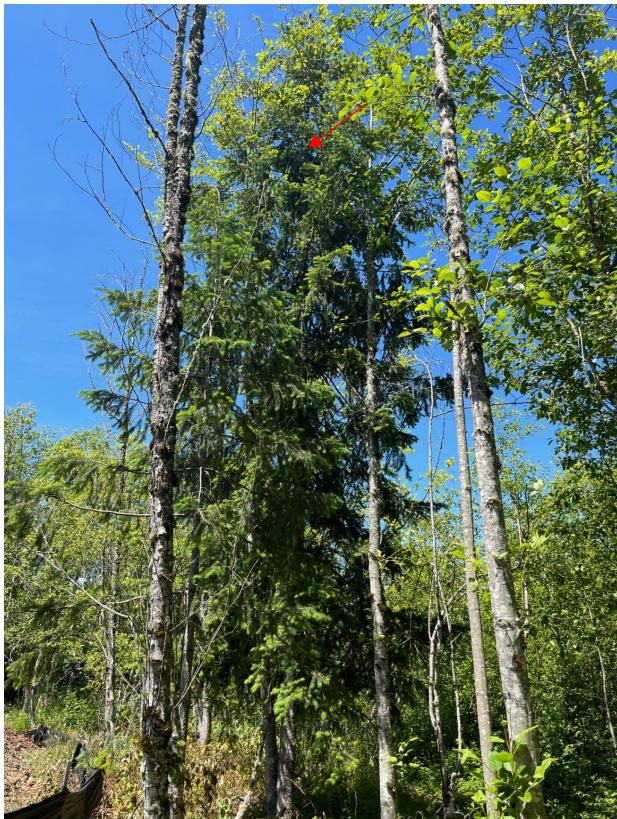
8-inch DBH Douglas-fir

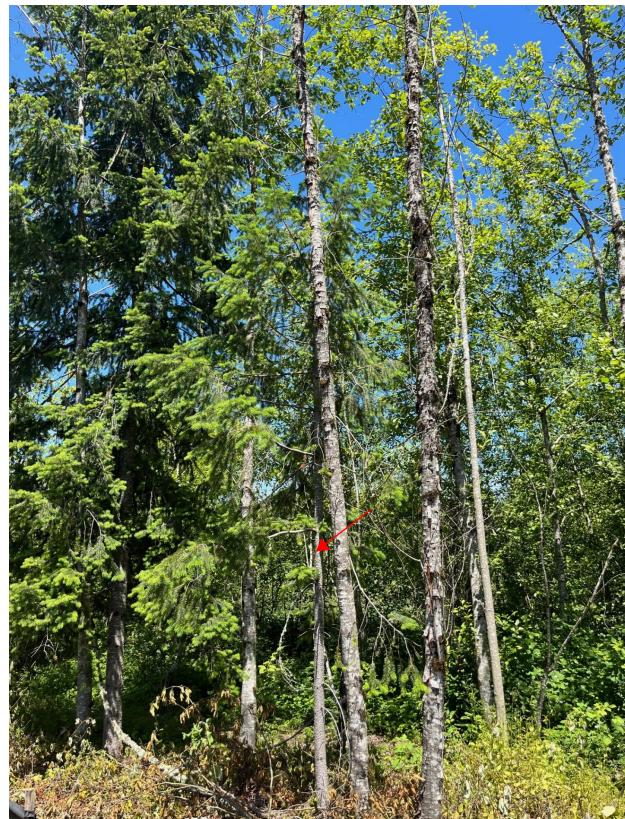
3-inch DBH Douglas-fir
